LAKE BURNT MILLS DAM

VA. 12303

PHASE I INSPECTION REPORT NATIONAL DAM SAFETY PROGRAM

DEWARD M. MARTIN & ASSOCIATES
WILLIAMSBURG, VIRGINIA
AUGUST. 1979

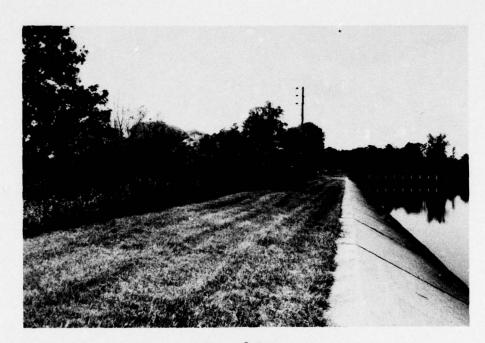
Top of Dam

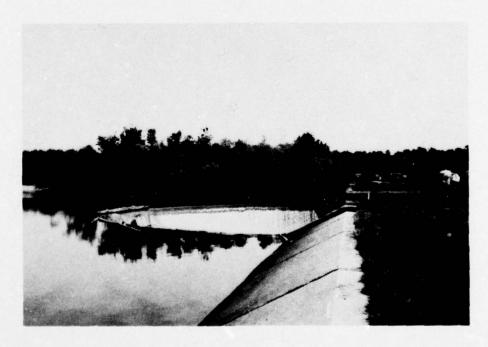
Spillway

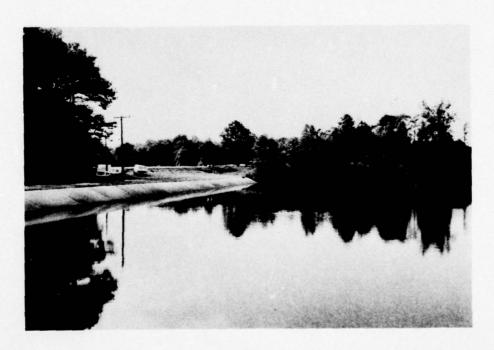
PHOTOGRAPH NO. 2 Upstream Face of Dam

- 3.1.2 Dam: The downstream slope of the dam right of the spill-way is heavily overgrown with vegetation, consisting primarily of small shrubs and grass. However, at the toe of the slope a large number of 6-18 inch trees exist. The downstream slope is relatively steep, 1.5(H): 1(V); however, no bulging of the slope or tilting trees at the base of the dam was observed. No erosion, sloughing, or misalignment were observed. The concrete slab on the upstream face of the dam adjacent to the right endwall of the spillway showed a 2-3 inch settlement.

- a) All the heavy vegetation, brush, and root systems should be removed from the dam embankment. All subsequent holes should be dressed with compacted fill and seeded.
- b) The settlement of the concrete slab and the cracks in the spillway should be monitored during the annual inspections.
- c) An annual maintenance and inspection program should be initiated to help detect and control problems that may occur.

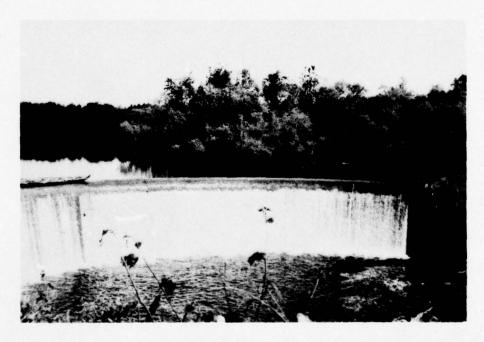
PHOTOGRAPH NO. 4
Spillway
Front View

- 3.1.3 Spillway: Hair line cracks were also found in the spillway.
- 3.1.4 Appurtenant Structures: The visual inspection revealed hair line cracks to the right of the concrete spillway in the abutment walls and spalling in the outlet concrete.
